Servicing Hitachi VT8000 Series VCRs

Derek Snelling

The Hitachi VT8000 series of VCRs comprises models VT8000, VT8300, VT8500 and VT8700. Similar models were released under the Granada name: in addition the mechanics were used in the Fidelity VTR1000. They were amongst the first "electronic" type VHS machines released in the UK, being on sale during the period 1980-2, and have proved to be very reliable. The VT8000 is the basic model, with a one-event, ten-day timer, visual search, freeze frame and frame advance (the noise bar is automatically shunted to the bottom of the screen), audio dub and a ten-function wired remote control system (some early machines had two-function only remote control, but the later units will work with them). The VT8500 was the "luxury" model, with a four-event timer, half and double speed playback without noise bars, a tape index system and infra-red remote control. These two initial models were subsequently replaced by the VT8300 and the

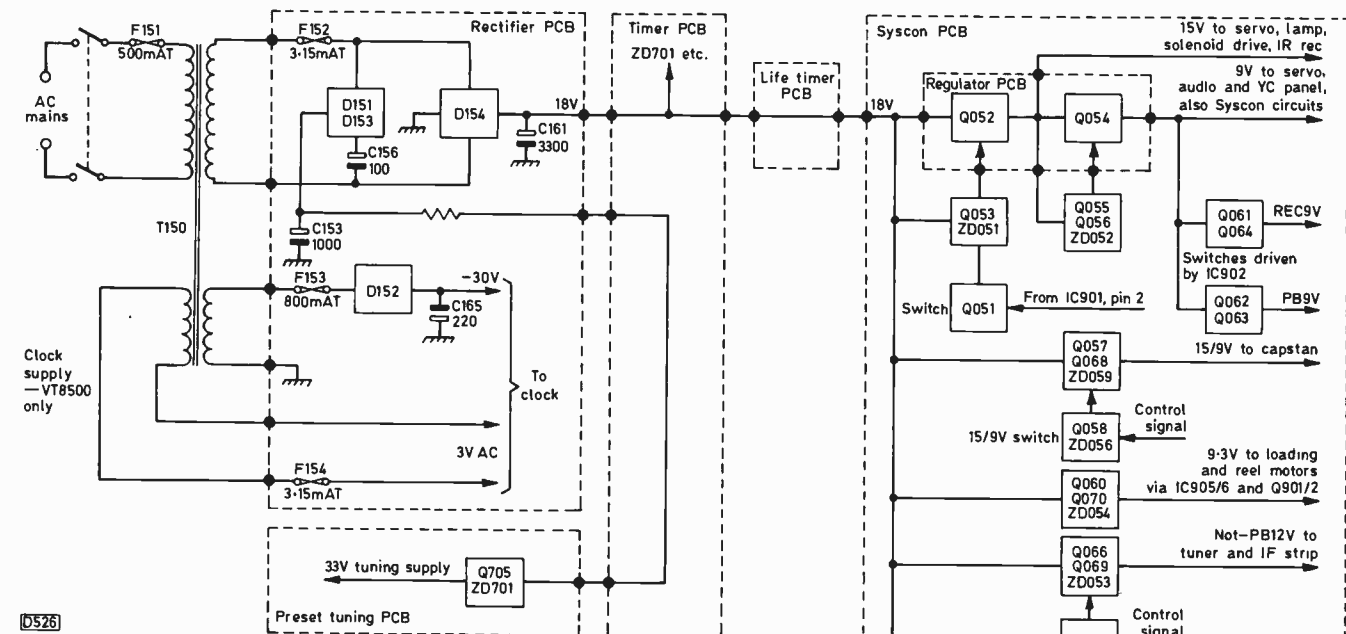
Fig. 1: Above, block diagram of the power supply arrangements used with the earlier VT8000/VT8500 machines. Left, changes introduced with the later VT8300/VT8700 machines.

Most of the faults with these machines occur in the power supply. This is spread over three boards. First the board which contains the rectifiers – three in the case of the VT8000/VT8300, four in the case of the VT8500/VT8700 – and the smoothers. Secondly the power transistor or regulator board, which with the VT8000/VT8500 contains the 9V and 15V series regulator transistors and with the VT8300/VT8700 contains an encapsulated 9V/15V regulator, also the bulb feed resistor and open-circuit detector. The rest of the power supply circuitry is on the bottom board, mainly along the left-hand edge. Fig. 1 shows block diagrams for the two versions of the supplies.

When dealing with a power supply fault remember that most of the lines are derived from other supplies so check for the highest missing voltage and sort this out first – the others will then usually be o.k. Common power supply faults with the VT8000/VT8500 are as follows. R054 (1.5k Ω , 0.5W) goes open-circuit or high in value, giving no switched 15V or derived supplies. R069 (1.5k Ω , 0.5W) goes open-circuit or high in value, removing the not-playback 12V supply. Q051 or ZD051 faulty gives no switched 15V or derived supplies. ZD055 faulty results in no microcomputer chip 5V supply. R081 (2.2 Ω , 0.25W) open-circuit gives no 10V supply for the reel or loading motors – this resistor was replaced with a posistor in the VT8300/VT8700 to overcome the problem. In addition to these common faults I've had most of the zener diodes fail at one time or another and a colleague had a faulty bridge rectifier which had the effect of extinguishing the clock display whenever play was selected. The different power supply arrangements in the VT8300/VT8700 result in greater reliability. IC651 on the regulator board can sometimes fail, removing the switched 15V and 9V supplies. R653 (220 Ω , 0.5W) on the same board can fail with the result that the cassette lamp is without a supply although the machine will continue to operate because of the nature of the detection circuit.

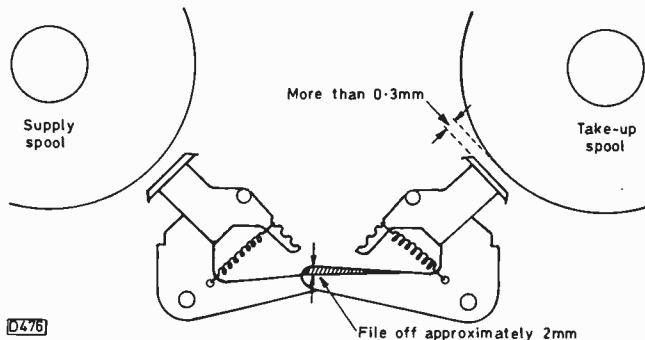
Fig. 2: Mechanical modification to cure tape damage due to looping when the machine stops after rewind.

The brake modification applies to all models. The problem is tape damage after rewind, caused by the fact that the supply spool brake comes on fractionally before the take-up spool brake, or the latter slips slightly, when the machine stops after rewind. The result is a tape loop which gets trapped in the cassette flap when the cassette is removed. There are two modifications for this, a mechanical one and an electronic one. The former consists of filing

a piece off one brake arm (see Fig. 2) to ensure that this brake comes on fractionally before the other. The latter
