There are three causes for complaints such as "distorted," "fuzzy" or "noisy" reproduction when playing records on the Model 296.

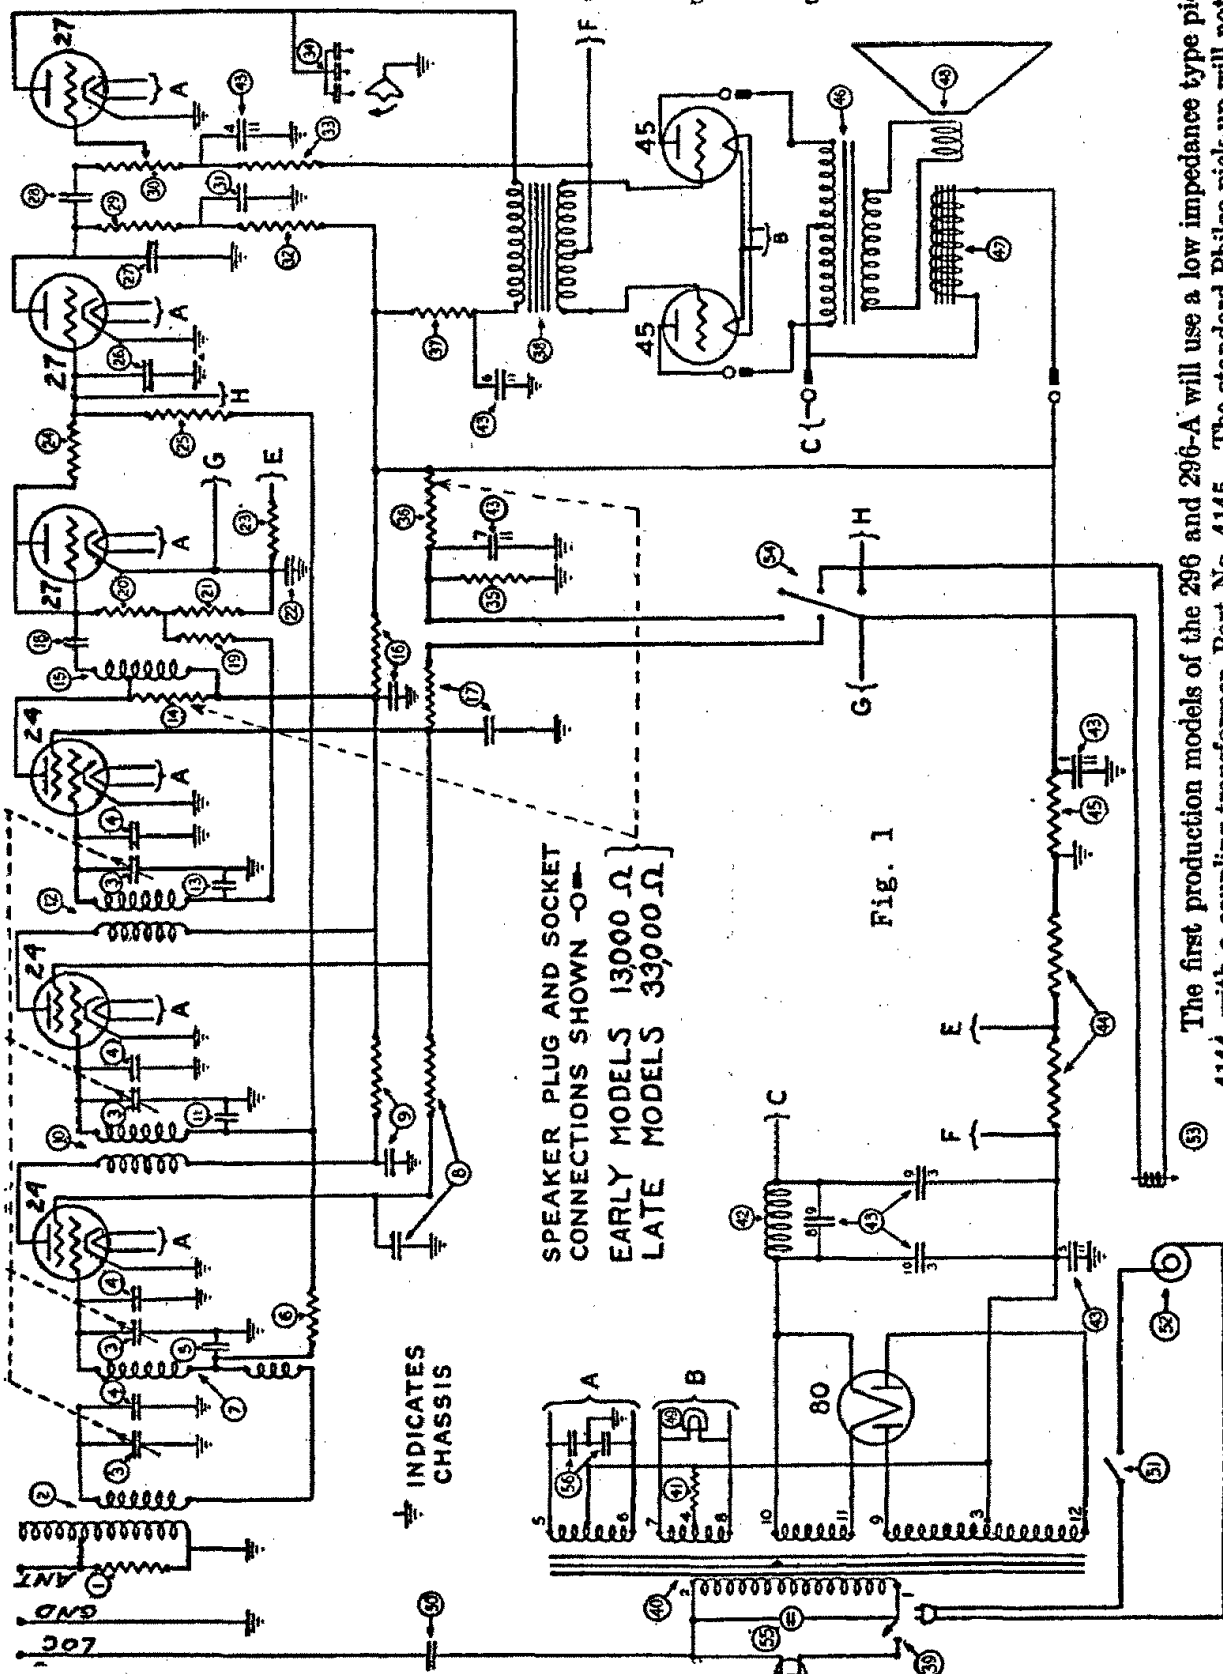
A heater by-pass condenser has been added to the 296 and 296-A chassis. The number in Fig. 1 is 66 and the part number is 3557. This condenser prevents any tendency of the Receiver to oscillate, which may have been noticed on the first few Radio-Phonograph Receivers.
