RCA VICTOR

MODELS 3-HES-5, 3-HES-5A

Schematic Diagram — RS-146

Chassis No. RS-146, RS-146X

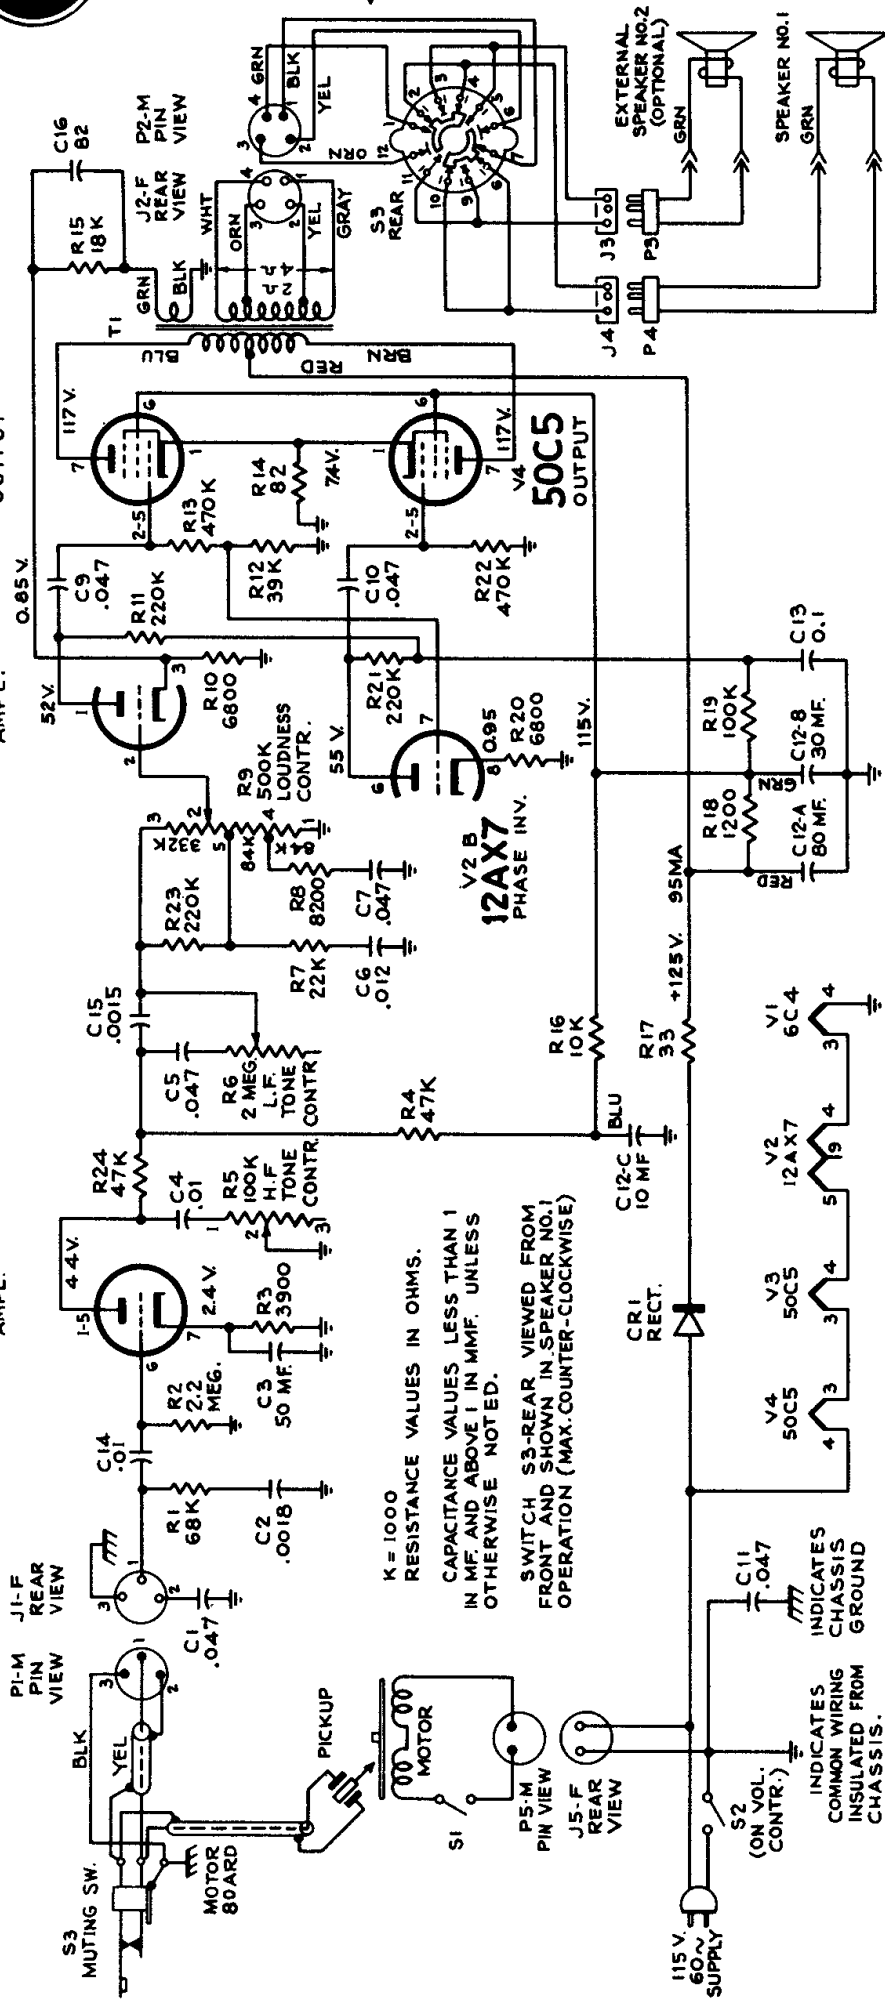
An electrostatic condition has been found to cause an accumulation of metallic dust and minute cuttings between the loudness control terminals and the chassis apron. This causes a partial short circuit and has been found to be the cause of a hum which is difficult to locate. Late production chassis have a coating of black insulating paint at this point.

The three-section electrolytic capacitor used in this chassis is of a specially selected type of construction. If replacement should be made with other than the specified replacement part (Stock No. 78617), excessive hum may be present. This hum may be due to excessive coupling between sections. If such should be the case, it is advisable to use a separate capacitor for C12C.

The loudness control should be examined when any of these chassis are serviced. This space may be cleaned with an air blast or with a soft brush.
