TECHNICAL BULLETIN NUMBER 7002

SUBJECT: SPEED CONTROL CAM

MODELS: PE 2018, PE 2020, PE 2038, PE 2040

TECHNICAL BULLETIN NUMBER 7003

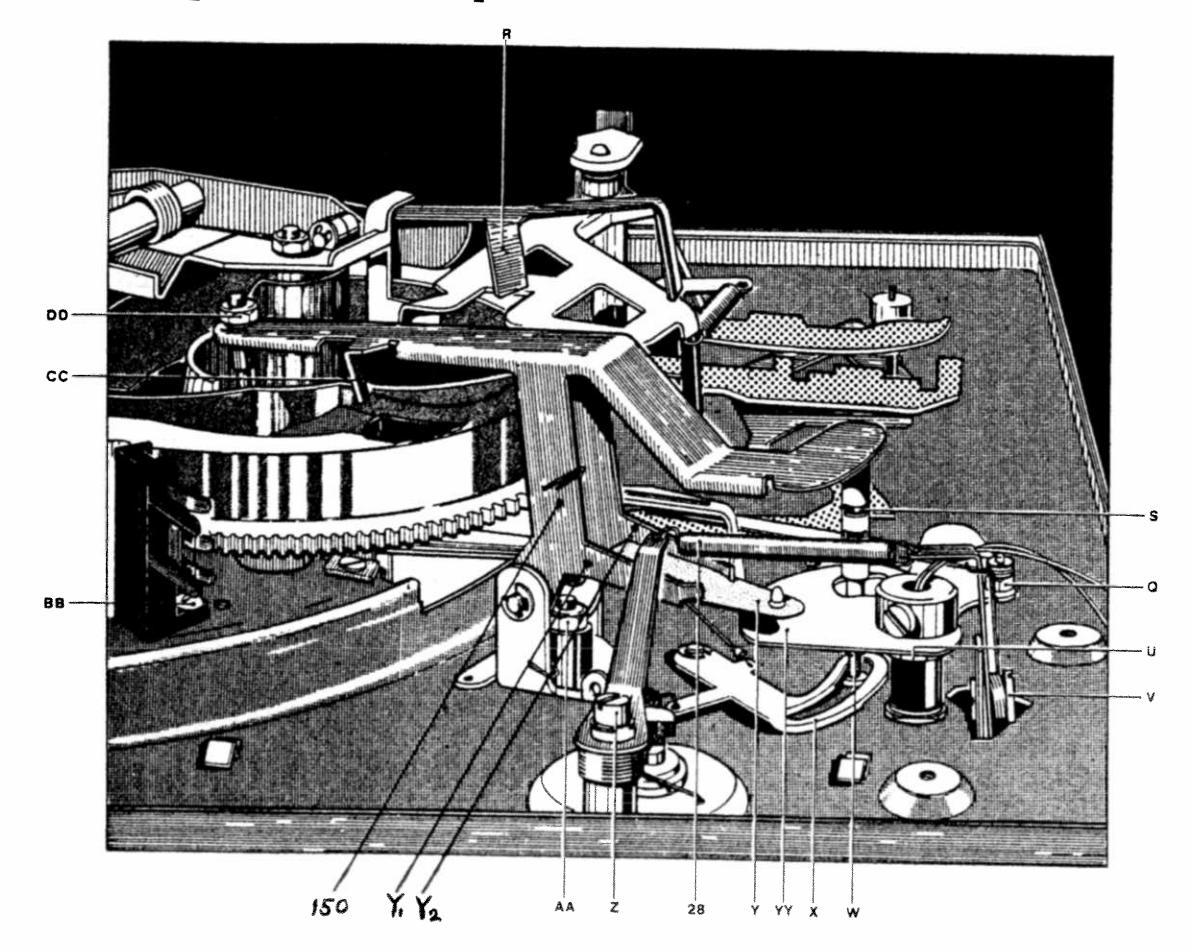
ADJUSTMENT

Cycle the turntable to the "cue up" position and measure the tonearm lateral friction force. It should be measured with a force gauge from zero (0) to fifty (50) grams and read between fifteen (15) and thirty-five (35) grams.

Increase the friction between the leaf spring "Y" and the tonearm locator segment "YY" by bending the two (2) arms of the feed lever assembly (150). Bend slightly both arms Y 1, Y 2, straight down the same amount so the plastic pin in the leaf spring remains parallel to the tonearm locator segment "YY".

Do not attempt to increase the friction by making the adjustment at point "DD". This will alter the height of the tonearm as well as disturb adjustments of other functions. Measure the tonearm friction (fifteen (15) to thirty-five (35) grams) after each adjustment.

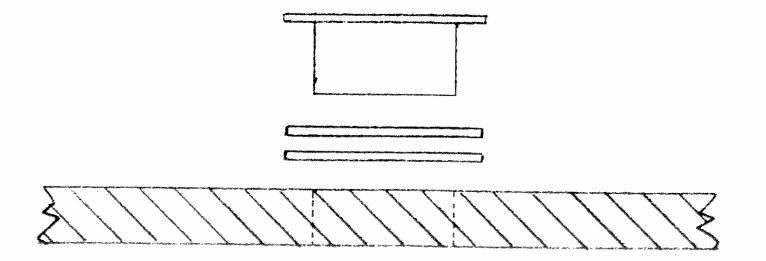
The PERPETUUM-EBNER factory maintains a tolerance of 3mm in the chassis mounting spring suspension. Evidence of extremes, of this tolerance, may be apparent in the form of a tilt in the chassis plate when the turntable is installed on the wood base (BV 18, BV 20 or LZ 2020).

To correct this problem, a kit consisting of plastic washers is available at no charge. The plastic washers are to be installed, as many as may be required to level the chassis, between the brass suspension cup and the wood base.

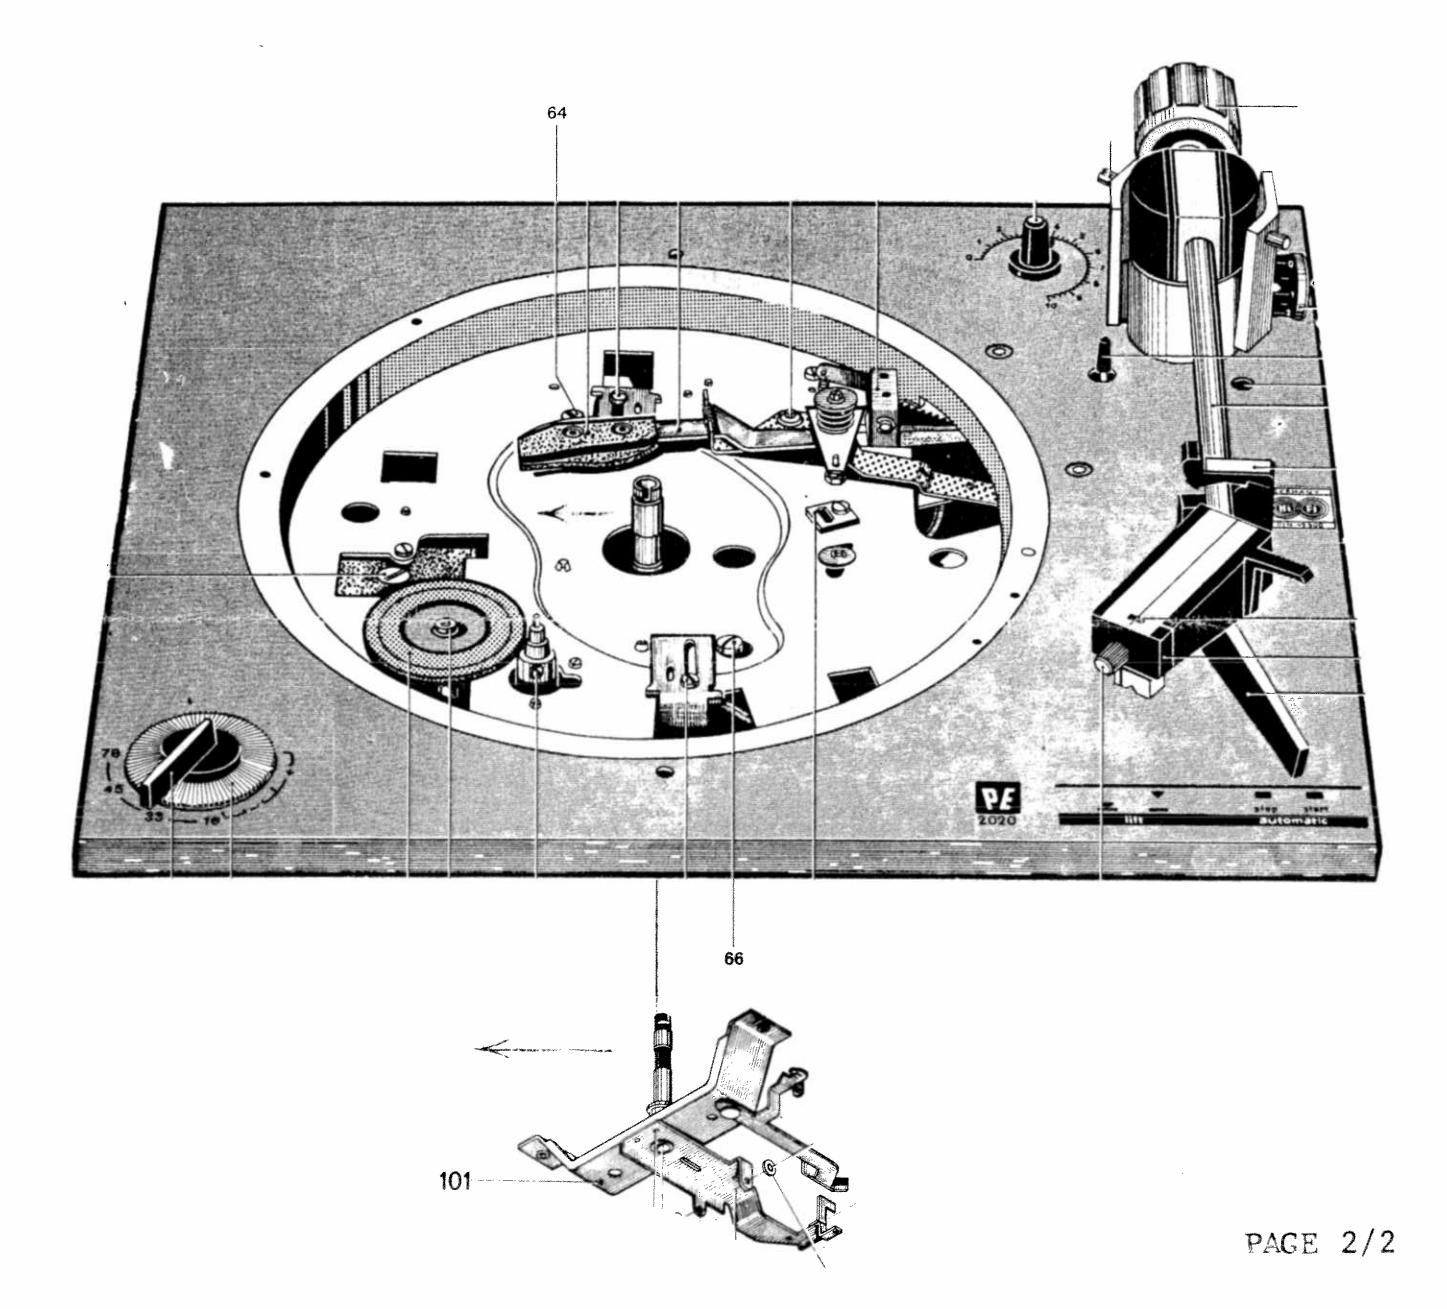
The cause of the thumping is the partial engagement of the teeth of the main cam assembly and the gear on the turntable platter once per revolution.

The complete bearing bracket assembly (item 101) must be shifted to the left of the turntable chassis. The bearing bracket assembly is secured to the chassis via two screws (items 64 and 66). Sufficient play should exist in the chassis holes to accomplish the necessary repositioning. If there is not, the two screws should be removed and the holes enlarged slightly with a small round file.

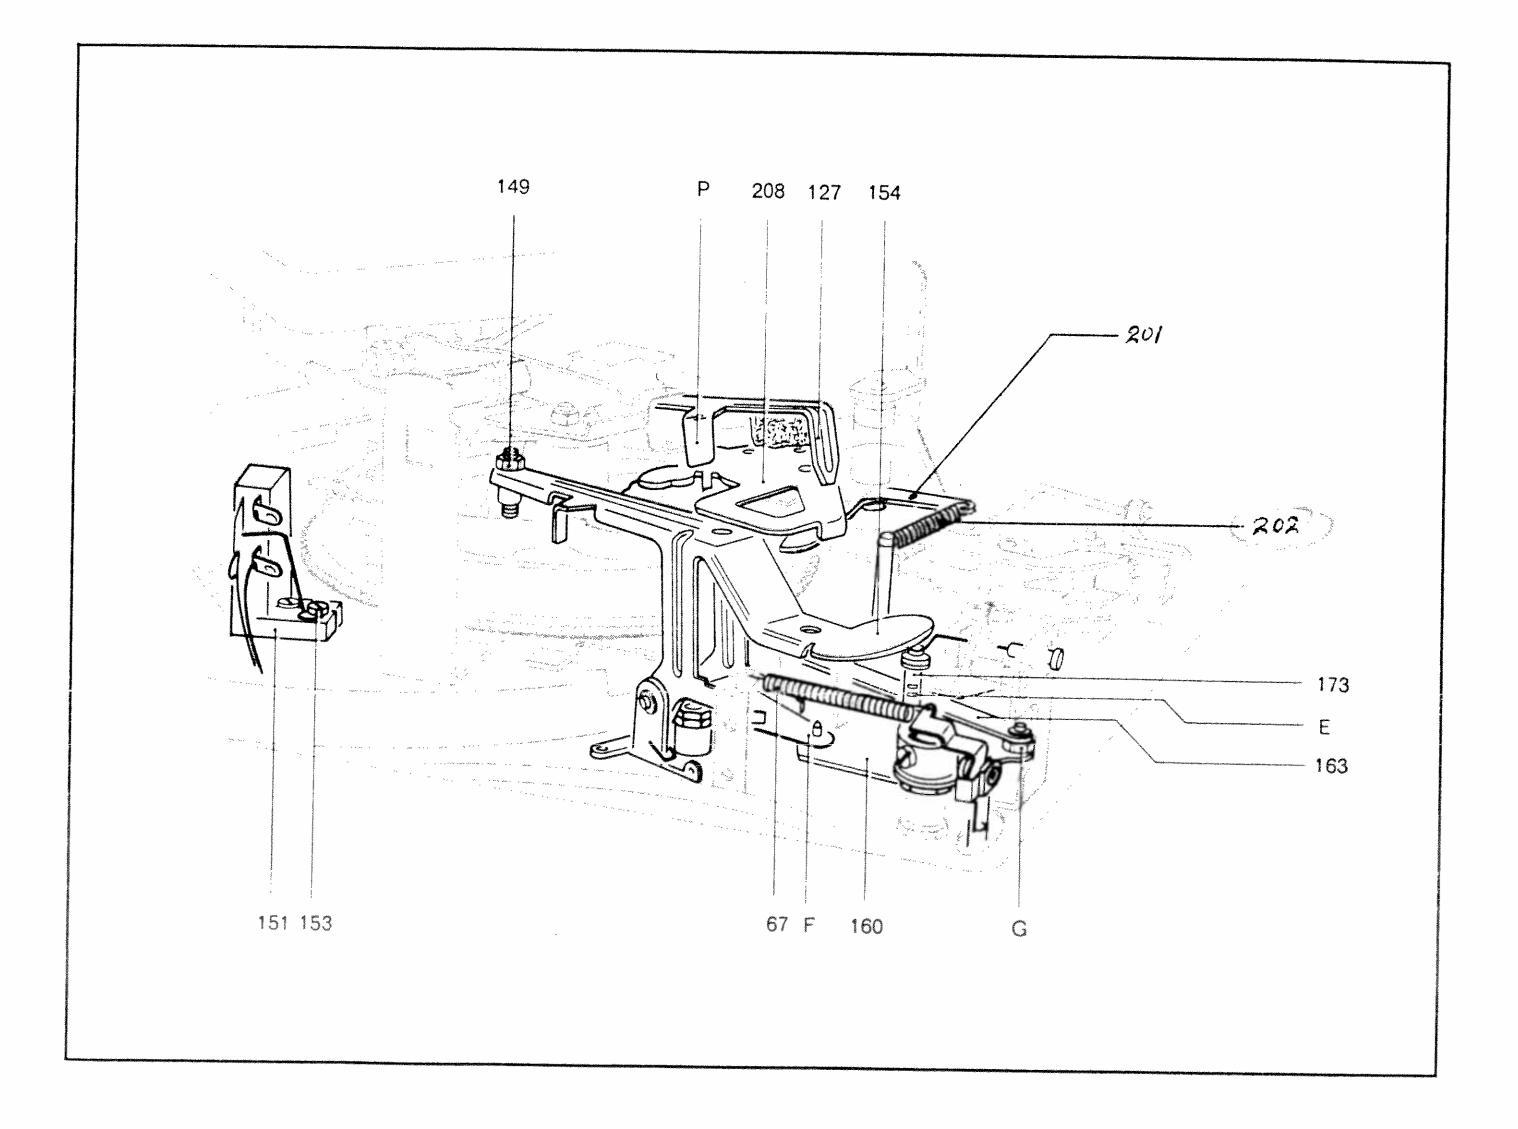
The lock pawl (201) plastic tip secures the main cam after completion of each cycle. However, after the "stop" operation the cam cycle may be incomplete. A slight pressure on the lock pawl, where the spring connects, will produce a "click" indicating the cam has not fully completed the cycle. Remove the lock pawl spring (202) and cut off approximately 1/3 of the coils (approximately 7 coils). Bend the last coil flat to form a hook and replace on the lock pawl and fixed post. Follow operational sequences a, b and c as described in PE Technical Bulletin No. 7007 and check for thumping once per revolution.

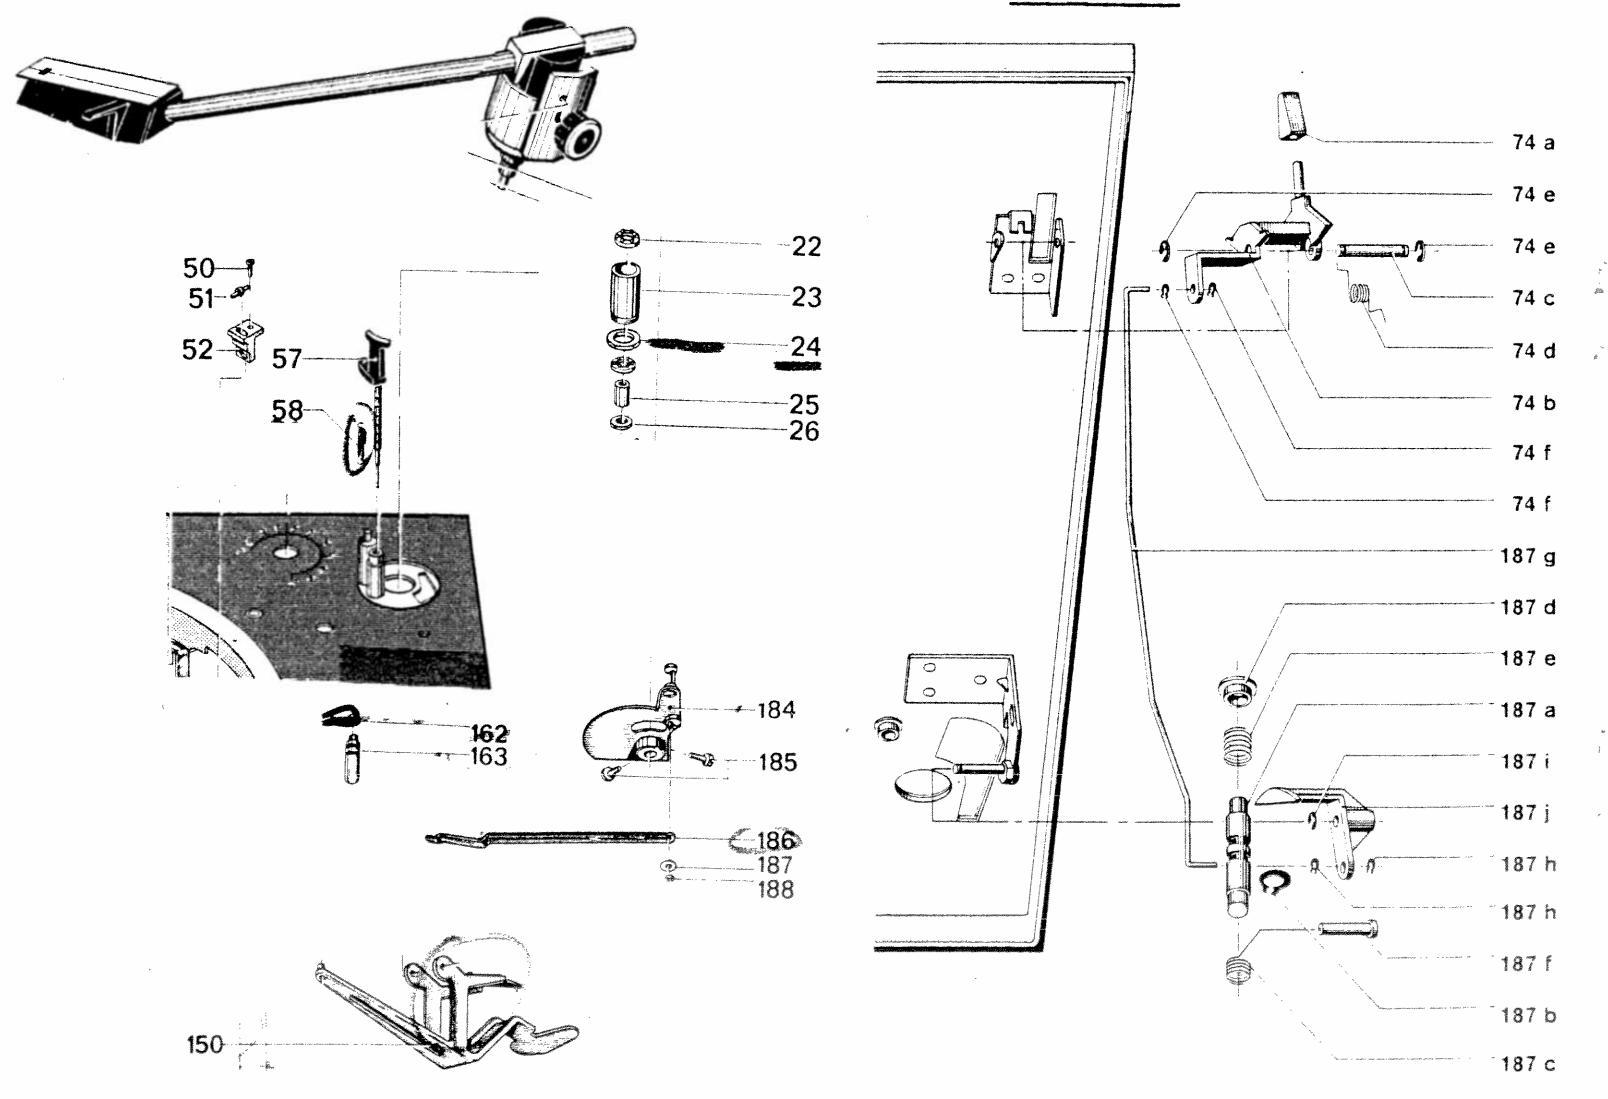
FIGURE 1

Loss of damping fluid in the cueing mechanism will result in a rapid or erractic descent of the tonearm and stylus assembly to the record after record change or cueing operations.

- 1. Remove the feed lever (item 150) Refer to figure 1
- 2. Disconnect and remove the trip link (item 186)
- NOTE: Do not lose the guide roller (item 51) which will fall out when the trip link is removed.

- 3. Remove the tonearm locator segment (item 184)
 - 4. Remove the cueing sleeve subassembly (item 163)
 - 5. Remove the lock nut (item 162)
 - 6. Remove Hex Nut (item 24)

- 7. Release the tonearm wiring harness by bending the tiedown tabs. It is not necessary to unsolder the tonearm wires from the muting switch.
 - 8. The tonearm and console assembly may be removed from the chassis and laid aside exposing the lift rod (item 57).

- 9. Disconnect the draw spring (item 58) and remove the lift rod and cylinder fitted to the chassis with a pipe cleaner moisten with alcohol or lighter fluid.

- 10. Apply a small quanity of silicon grease evenly to the notched shaft of the lift rod. Replace the lift rod and draw spring.
 - 11. Fit a counterweight and weighted cartridge slide to the tonearm. Zero balance the tonearm and apply approximately 2 grams stylus force by holding the tonearm and console assembly in place on the chassis by hand.
