QUAD ESL-63 service data

description

The Quad ESL-63 is a full range electrostatic loudspeaker doublet. It consists of a very light electrically polarised diaphragm suspended between two sets of concentric annular electrodes. Signal is fed to the electrodes via sequential delay lines and the motion of the diaphragm produces a sound pressure pattern which is an exact replica of that from an ideal source placed some 30 cms behind the plane of the diaphragm.

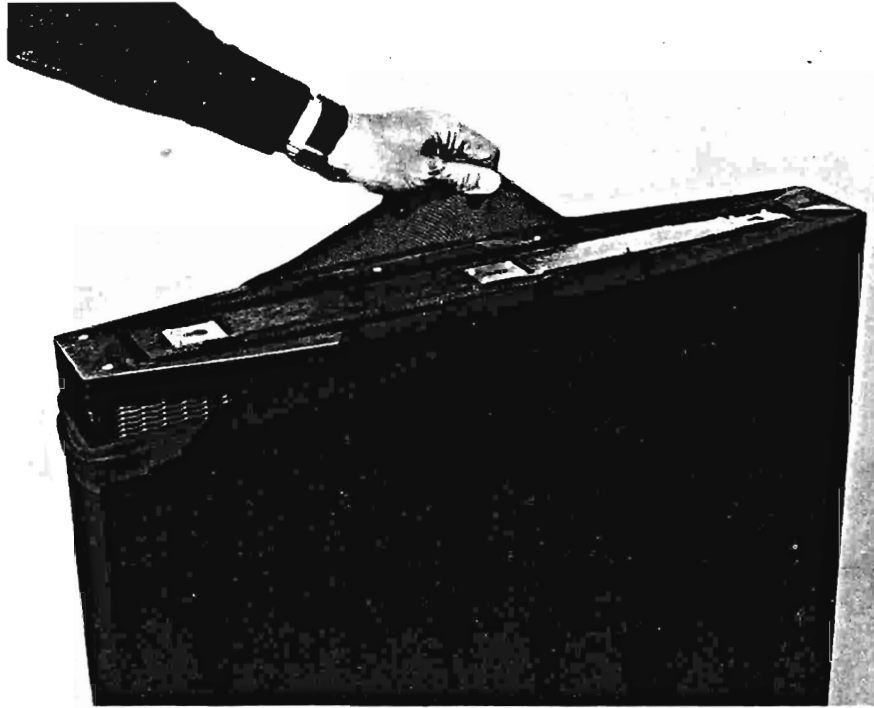
Fig. 8

- (a) Remove the wooden top from the loudspeaker by sliding it to the right (viewed from the front). Detach the grille cloth from the velcro hooks as shown in Fig. 8, and pull the cloth down taking care not to ladder it.

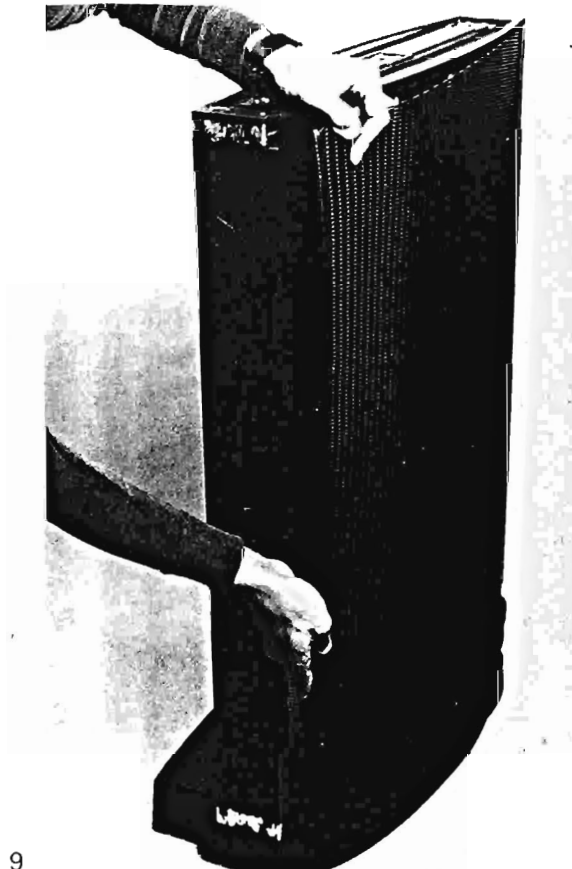
Fig. 9

- (b) The grilles are taped top and bottom to prevent rattles and once the tape has been removed it is possible to prise the front and back grilles from their retaining slots in the side extrusion. Care should be taken when handling the grilles as it is relatively easy to distort the edges beyond repair.

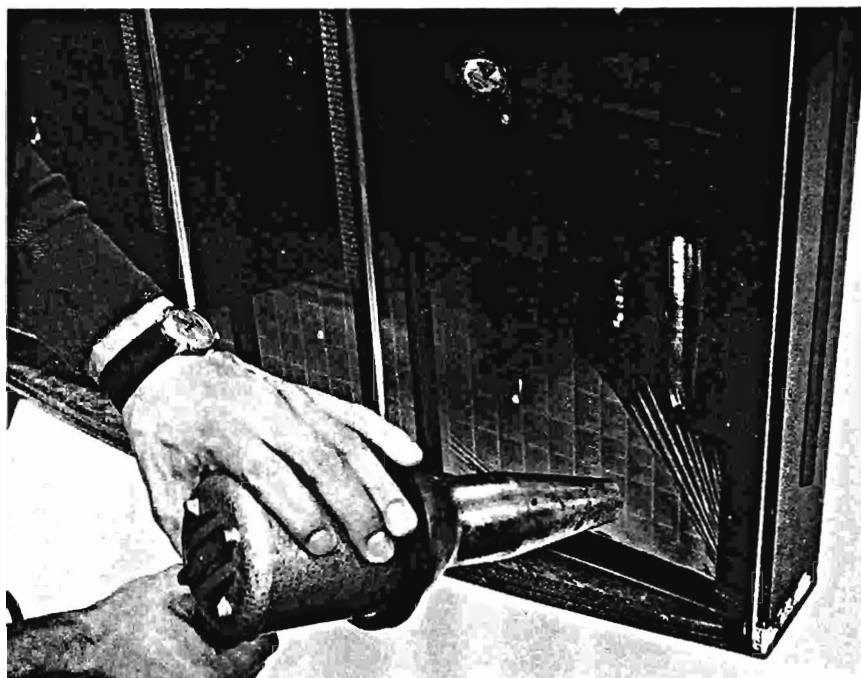
Fig. 12

- (e) With the faulty element replaced the loudspeaker can then be re-assembled in reverse order. Once the dust covers are in place they must be retensioned with a hot air blower to remove all wrinkles. A domestic hair dryer may not be hot enough but restricting the air flow by hand will raise the temperature sufficiently. The blower should be kept moving all the time in order to prevent burning a hole in the material.

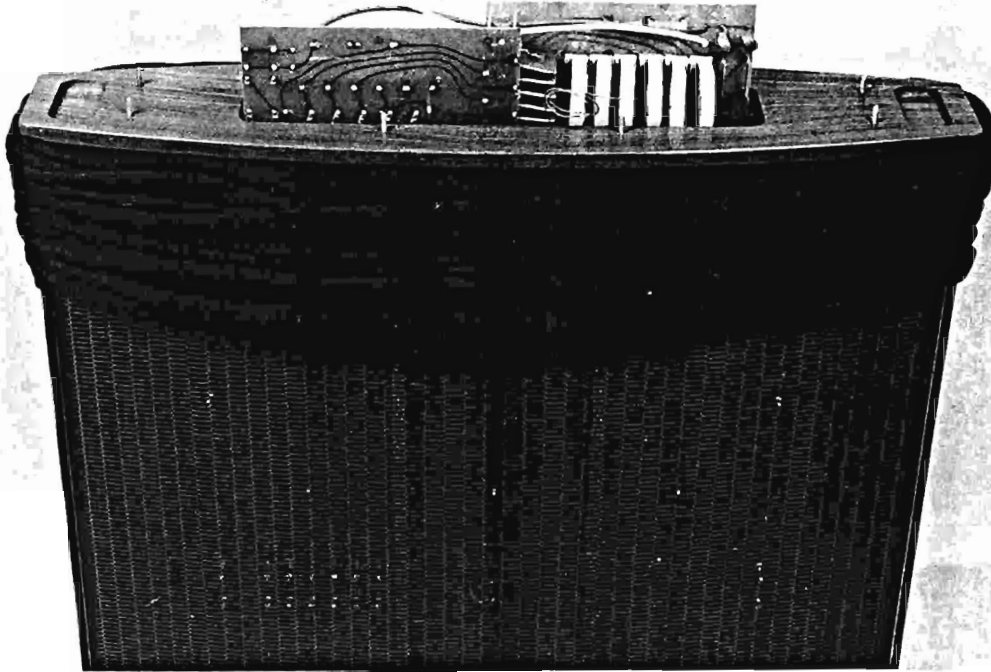
Fig. 13

- (b) Lift off the wooden base. Disengage the existing cloth from the velcro fixings at the bottom of the loudspeaker assembly and remove. Slip the new cloth over the inverted loudspeaker leaving about 2" projecting above it, with creases down the middle of the sides. Align the pattern with the corners, always taking great care not to ladder the material. Fix the cloth to the velcro fixings starting at the centre of each side and working out to the ends. Fold to form mitre pleats at the corners and attach to the velcro at the ends. Recheck the alignment of the pattern and adjust if necessary.

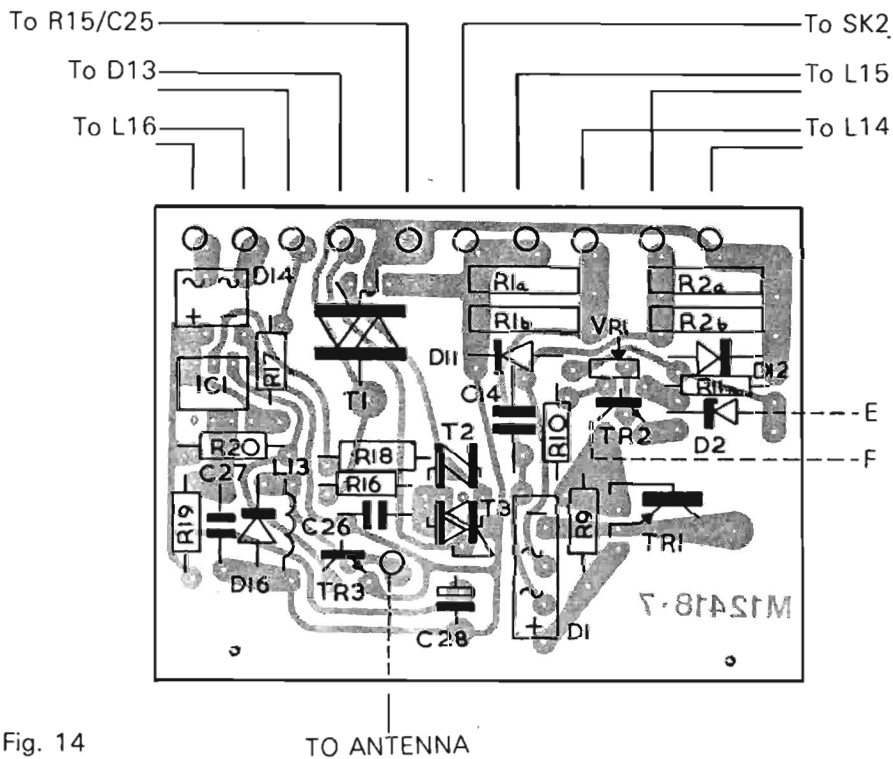
Fig. 14

M12418 - ISS 7

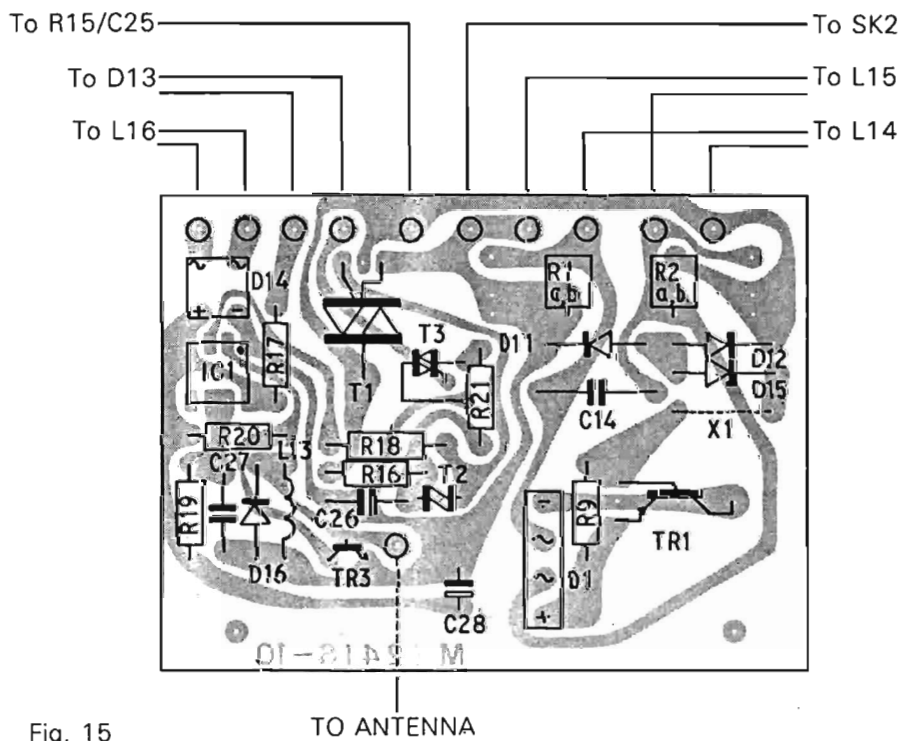
Fig. 15

M12418 - ISS 9, 10

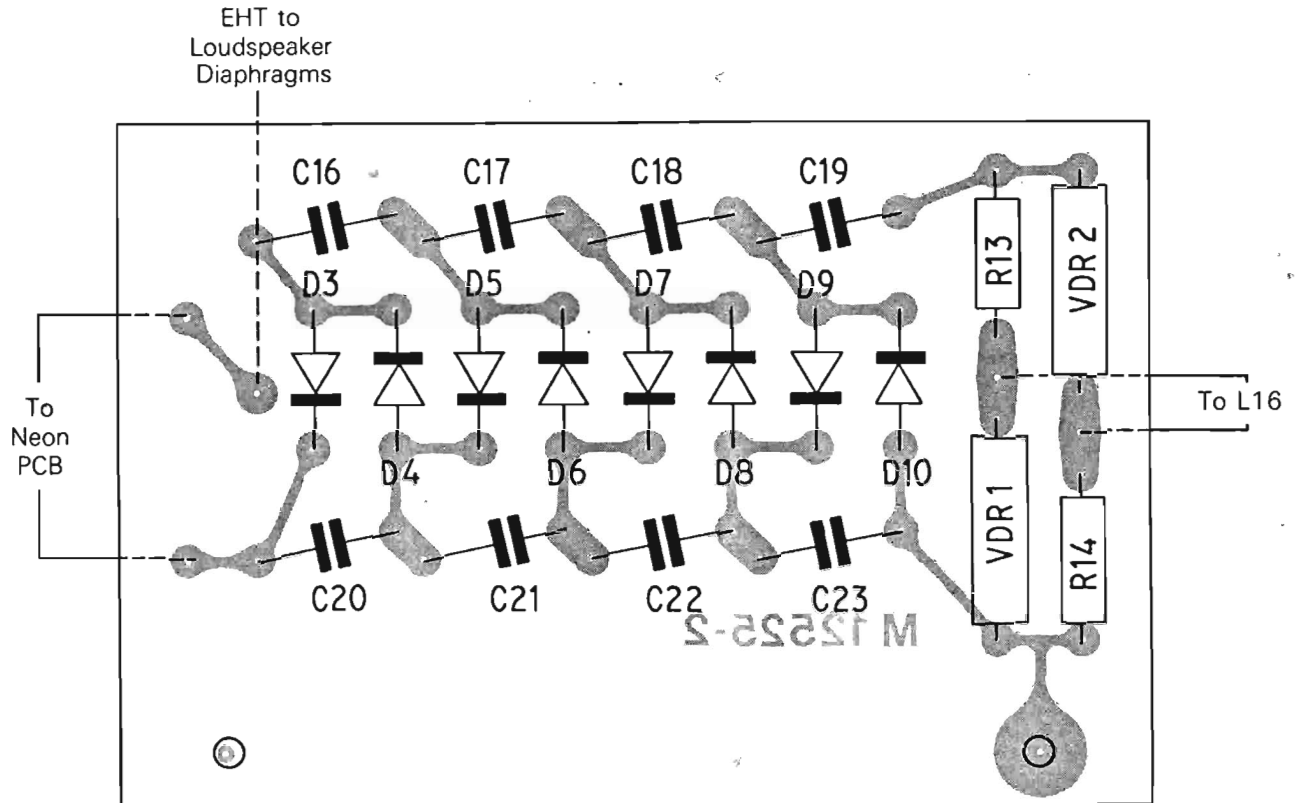
Fig. 16

M12525 - ISS 2

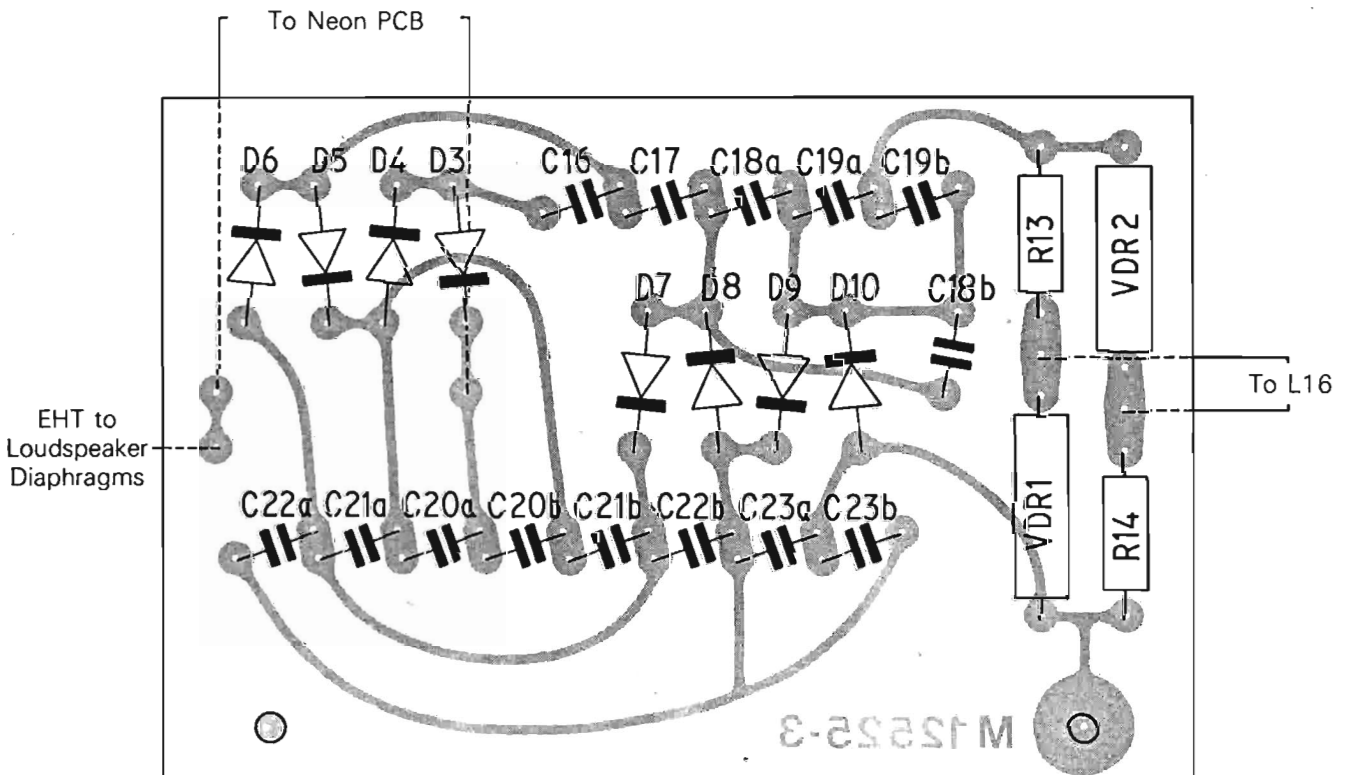
Fig. 17

M12525 - ISS 3
