DESCRIPTION

Montgomery Ward Radio Model 62-233

Service Notes

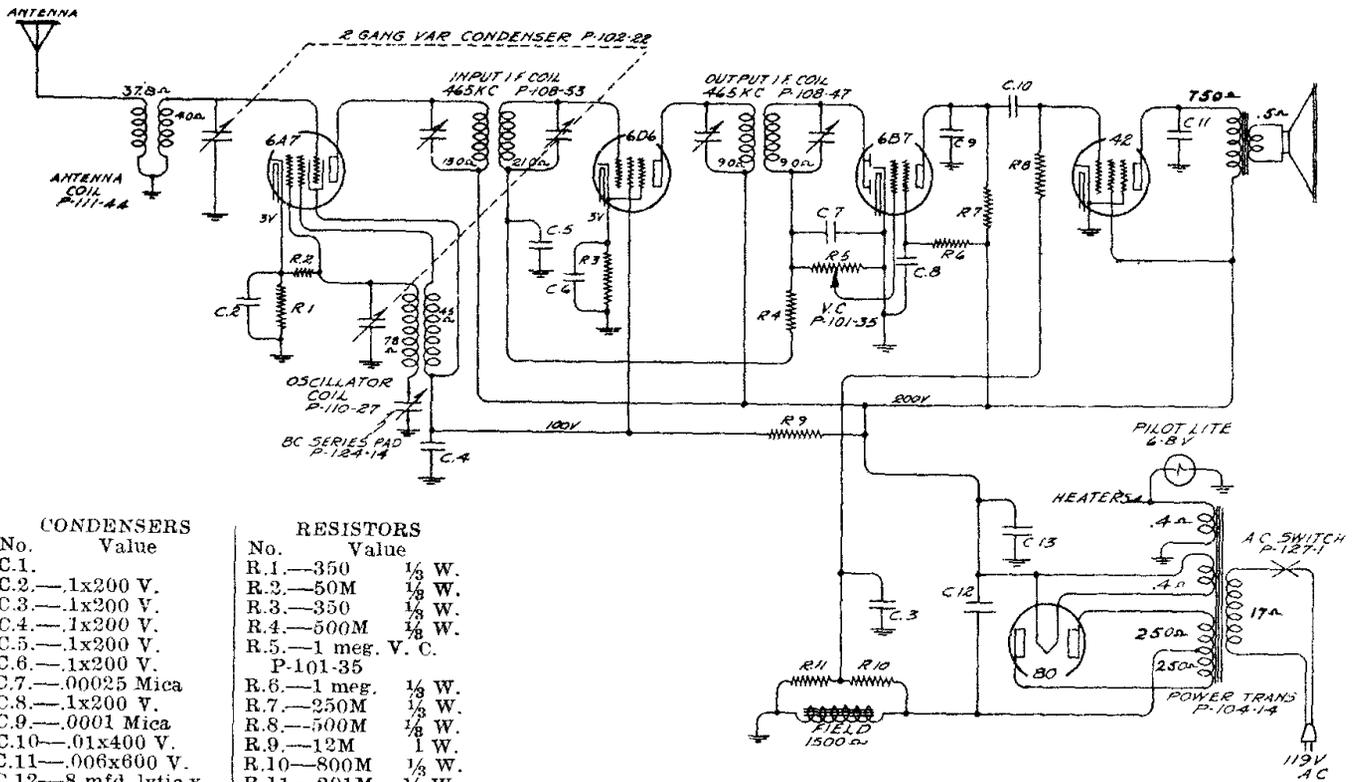
Voltages taken from different points of circuit to chassis are measured with volume control full on, all tubes in their sockets and speaker connected, with a volt meter having a resistance of 1000 ohms per volt. These voltages are clearly indicated on the circuit diagram.

Resistance of coils and transformer windings are indicated in ohms on schematic circuit diagram.
