Schematic Wiring Diagram Victor Radio and Victor Radio with Electrola
 Model R-32, R-52, RE-45, RE-75

R-32, R-52, RE-45 and RE-75

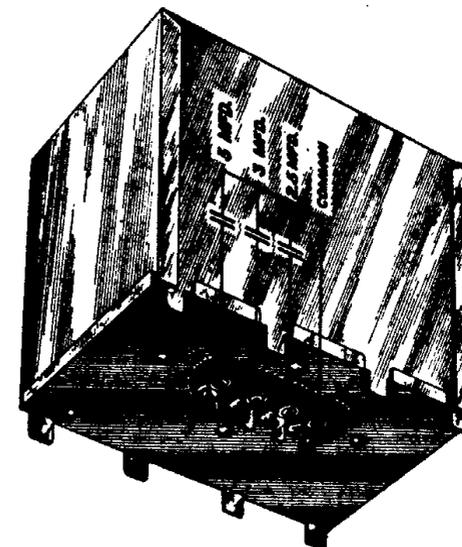
Internal Connections of Filter Condenser Bank

- Improperly adjusted or faulty hum controls. See subject 4, under Installation.
- Defective UX-280 or UY-227.
- Wire or terminal grounded to the frame, or open circuit in any of the various ground connections.
- Shorted condenser, 10, Fig. 1, across UX-226 filament supply.
- Open or shorted center tap resistor, 43, Fig. 1, across UX-226 filament supply.
- Shorted condenser, 64, Fig. 3, across power line in power-amplifier unit.
- Shorted condenser in condenser bank, 56, Fig. 2, of power-amplifier unit.
