## **Ansley 32A**

### Chevrolet 985792

#### Crosley 56PA, 56PB

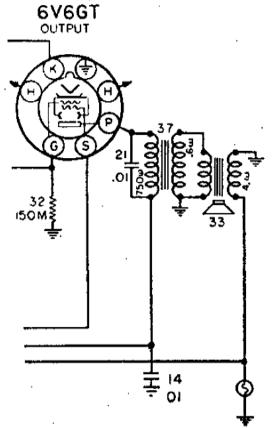
In the production of this model between serial numbers B46-130000 and B46-136522 the following changes have been made: the 22,000-ohm resistor, 24, has been changed to 33,000 ohms; and the 0.01 µf capacitor, 14, has been moved

Partial schematic of Chevrolet 985792 showing changes.

from between the 33,000-ohm resistor, 25, and ground to the primary of the output transformer, 37, which is connected through the capacitor to ground, as shown in the accompanying illustration.
