SERVICE SHEET

SERVICE SHEET No. 285

HE Beethoven P107 Super Minor portable receiver is a 4-valve battery-operated model with its own frame aerial. The cabinet is of the suitcase type, a turntable being fitted to the bottom. Provision is made for an external aerial and earth and for an extension speaker or headphones.

BEETHOVEN P107

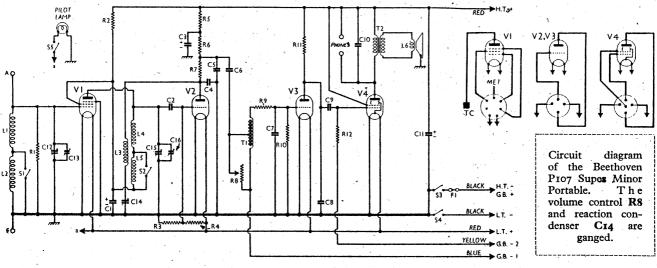
CIRCUIT DESCRIPTION

Tuned frame aerial input L1, L2, C12 to RF pentode valve (V1, Mullard metal-lised VP2) which operates as RF amplifier with fixed grid potential. Provision for connection of external aerial and earth if

Tuned anode coupling by L4, L5, C15 between V1 and triode detector valve (V2, Mullard metallised PM2HL) which operates on grid leak system with C2, R3, R4. Reaction is applied from anode by coil L3, and controlled by C14. RF filtering in anode circuit by R7, C4. Fixed tone correction in anode circuit by C5.

Auto-transformer coupling by R6, C6, manual volume control R8 and T1 between V2 and triode AF amplifying valve (V3, Mullard metallised PM2HL). Fixed tone correction in anode circuit by C8. RF filtering in grid circuit by R9, C7.

Resistance capacity coupling by R11, C9 and R12 between V3 and beam tetrode output valve (V4, Osram KT2). Fixed tone correction in anode circuit by C10. Provision for connection of headphones

across primary of speaker input transformer T2.

Fuse F1 in HT negative lead affords protection from damage in case of accidental short-circuit.

C11 is HT circuit reservoir condenser.

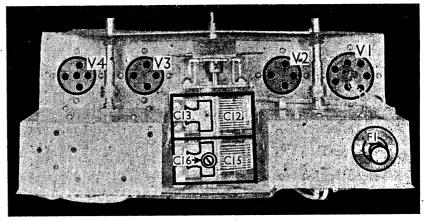
Plan view of the chassis. C13 was not used in this sample.

Trimmer C13.—In our chassis the adiabetic of this

justing screw and mica dielectric of this was taken out at the works, the trimmer not being used.

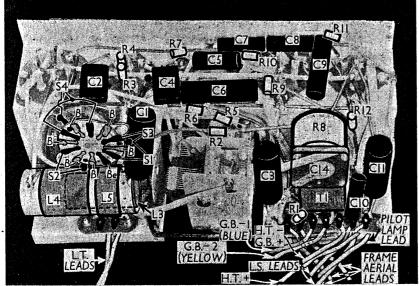
The individual switches in the rotary unit are indicated, as Under-chassis view. are also the various leads emerging from the chassis.

Switches.—S1 and S2 are the waveband switches, and S3 and S4 the battery circuit switches, ganged in a single rotary unit beneath the chassis. The individual switches are identified in our under-chassis

view, and no separate diagram is given. All the switches are closed on MW (control knob turned fully anti-clockwise), and

open on OFF (centre position). On LW (control knob fully clockwise), S1, S2 are open, and S3, S4 are closed.
