MODEL X825

MODELS 720, 721, 770, 771, 870 and 871

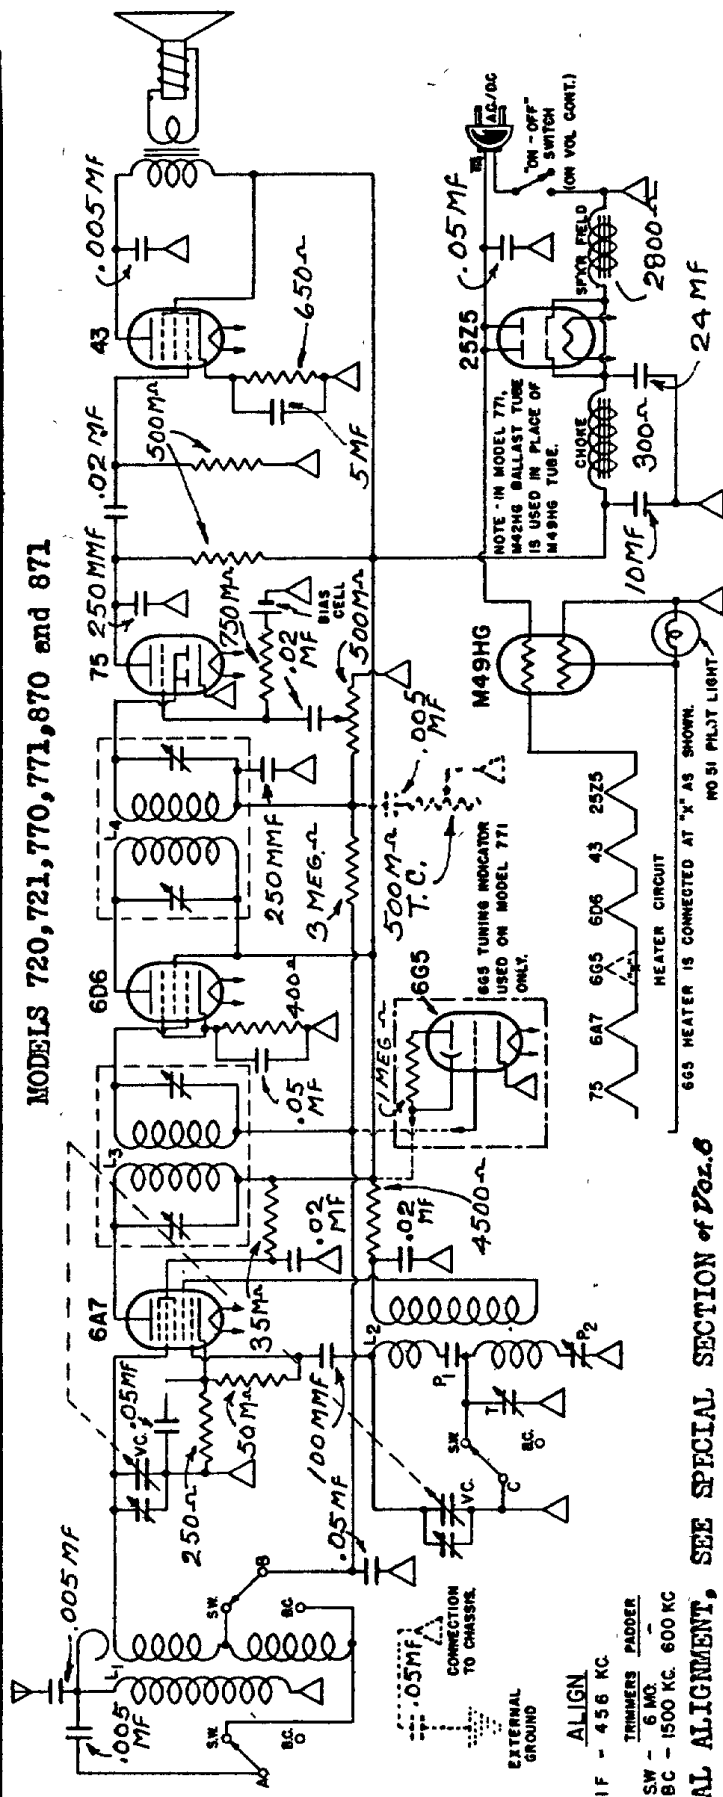
THE RECEIVER
MODELS 720
AND 721 DO
NOT USE THE
EXTERNAL,
CHASSIS
GROUND CON-
NECTION OR
THE TONE CON-
TROL, SHOWN
IN PHANTOM.
OTHERWISE
THE SCHEMATIC
IS CORRECT
FOR THESE
MODELS.

CONVENTIONAL ALIGNMENT, SEE SPECIAL SECTION OF VOL. 8
