RCA VICTOR

MODEL 66E

Chassis No. RS-126

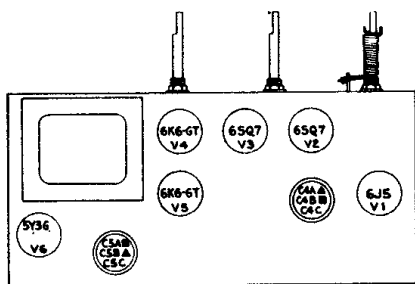
1. All leads and parts connected to the 6J5 socket should have sufficient slack to insure flexibility of socket.
2. The green lead from the center terminal of R10 volume control to terminal #2 of the 6SQ7 socket should be dressed up and away from all other leads and parts.

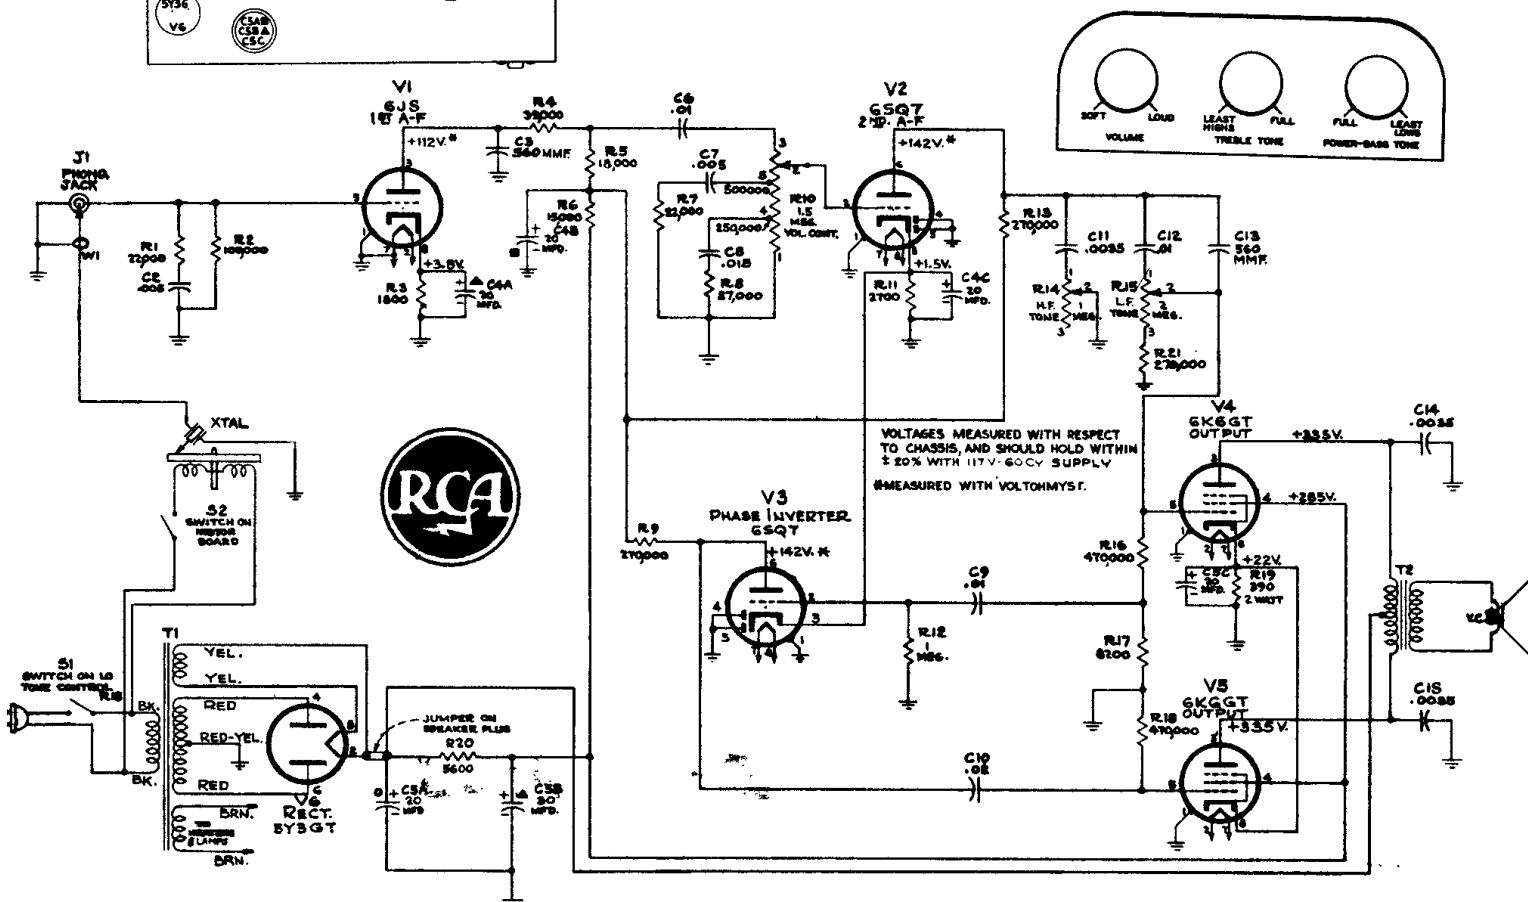
This instrument is provided with a Volume Control Lock, which can be adjusted in such a manner that will permit the control to be operated from zero to some pre-determined "Maximum" level to which it has been locked.

1. While instrument is in operation, remove Volume control knob.
2. The ends of two different weight springs can be seen in the Volume control shaft opening in the cabinet.
3. Turn Control "Maximum" clockwise until it is against stop.
4. To INCREASE desired maximum Volume level—
 - (a) Apply just enough force (to unlock volume control shaft) with the eraser end of a pencil, on the end of the light weight spring, in direction indicated in sketch "B"

- (b) Rotate volume control shaft in direction indicated until desired level is reached.
 - (c) Releasing force on spring automatically locks control so it can be operated from zero to the level where it has been locked.
5. To DECREASE desired maximum Volume level—
 - (a) Apply force with the eraser end of a pencil on the heavy weight spring as indicated in sketch (c).

- (b) Rotate to a very low level, then proceed as in step 4.

NOTE: The procedure in step (5b) is necessary to prevent possible error that may be introduced due to backlash.
