Zenith Radio Chassis 5Z21, Models HFZ18R and HFZ19E

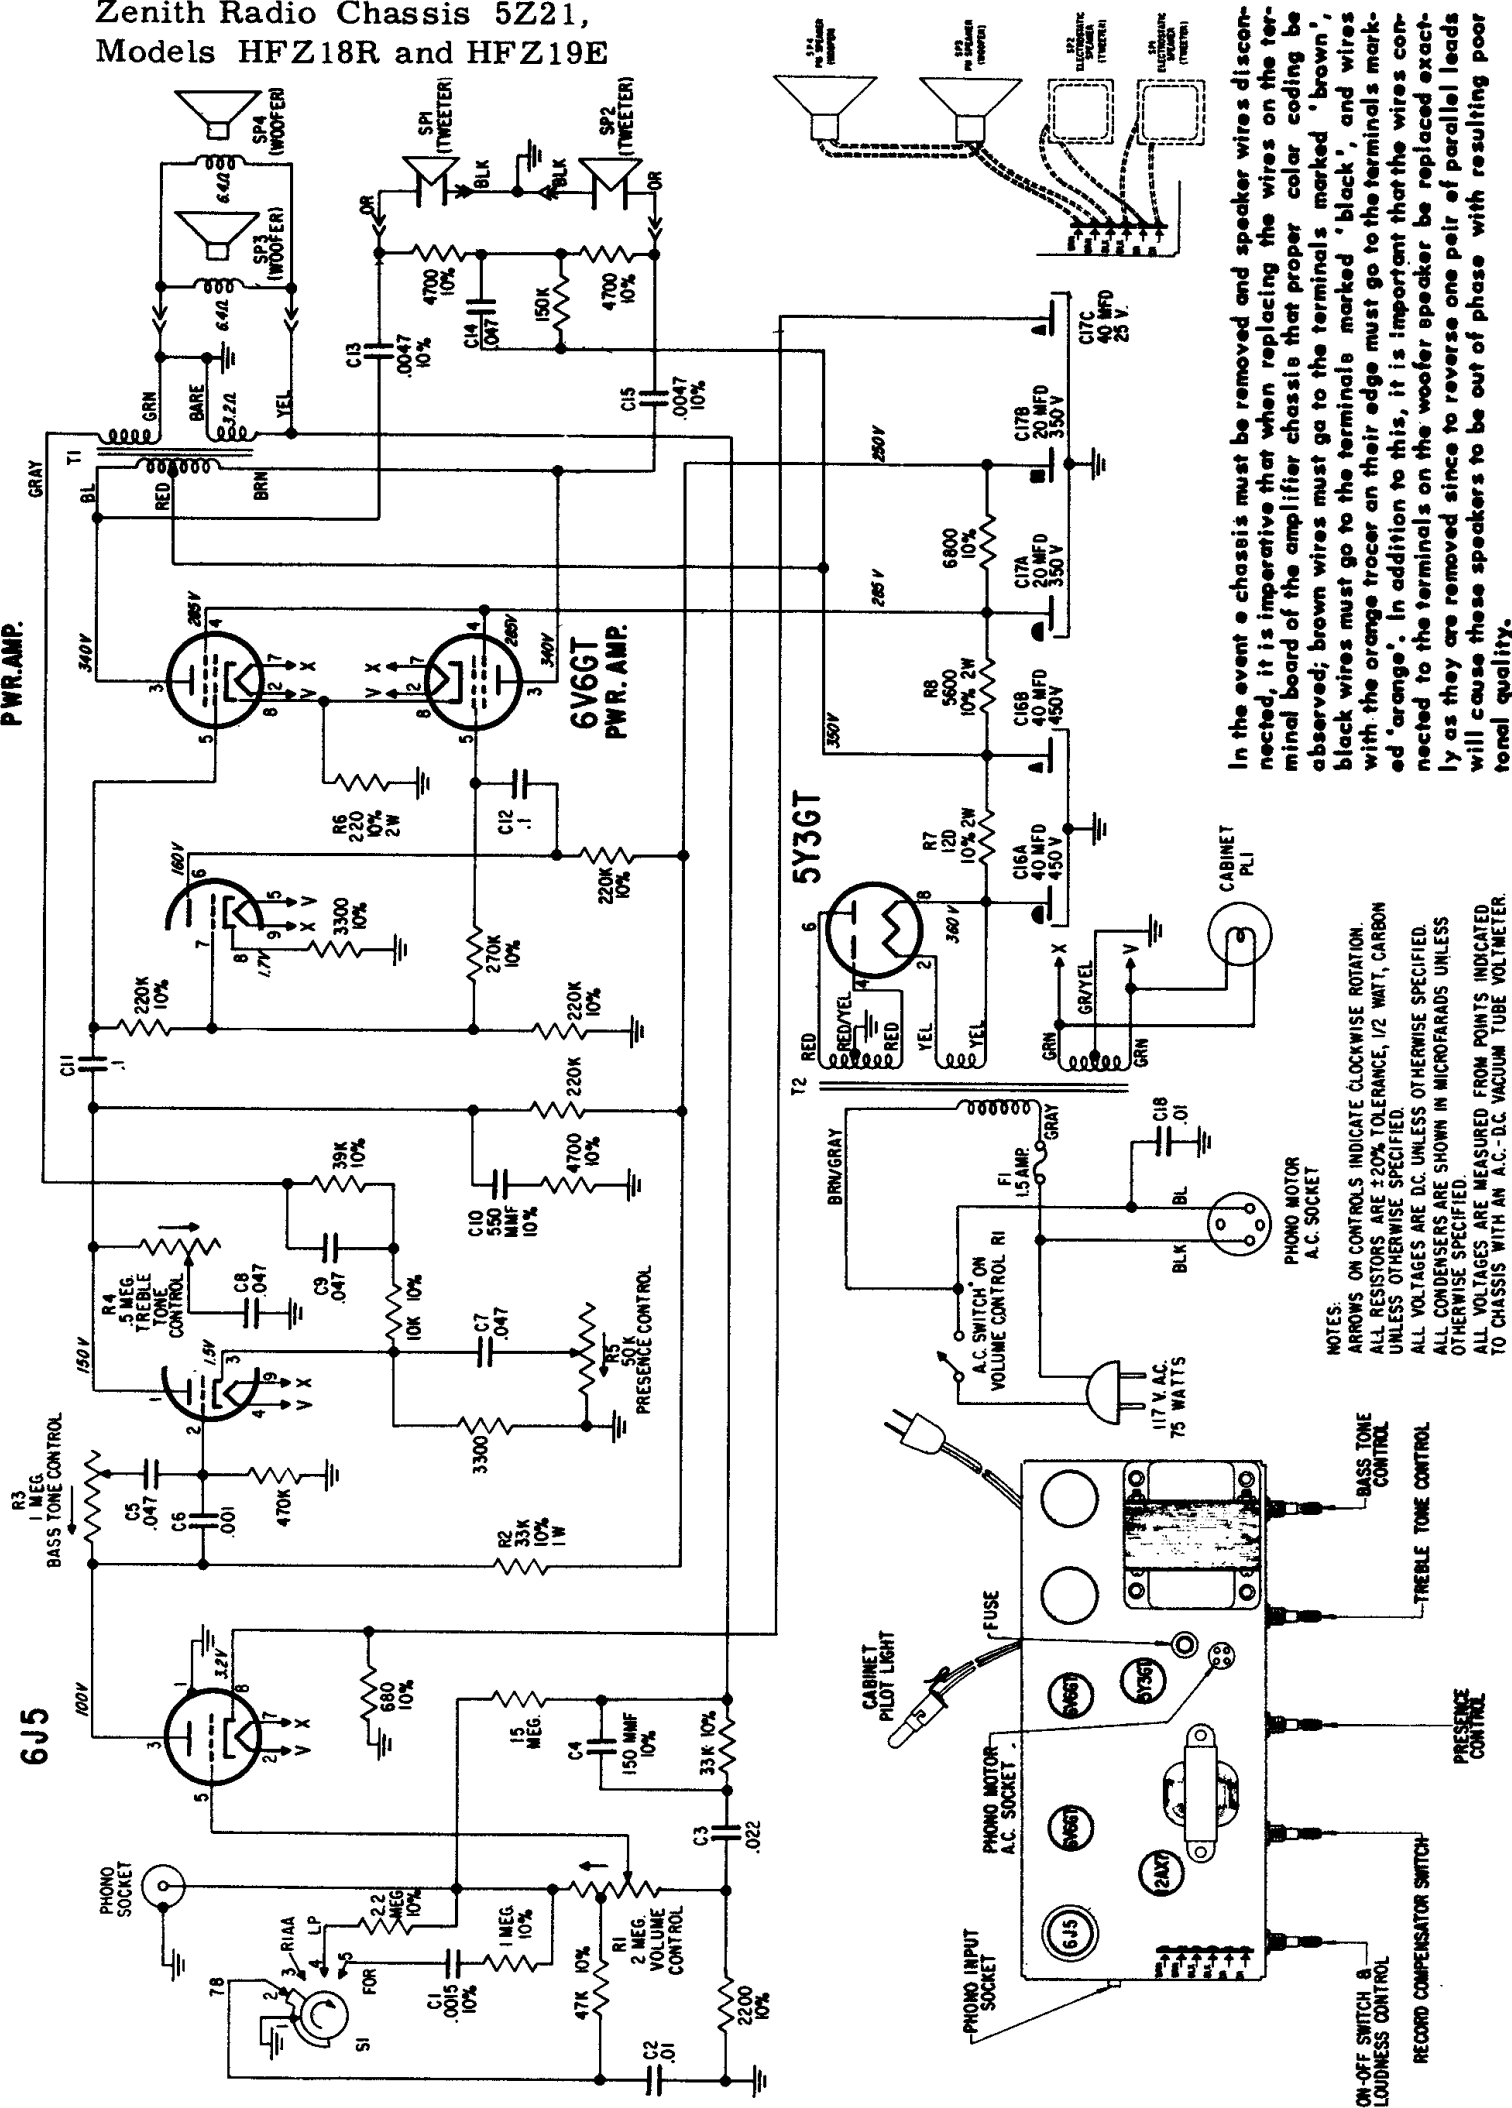
In the event a chassis must be removed and speaker wires disconnected, it is imperative that when replacing the wires on the terminal board of the amplifier chassis that proper color coding be observed; brown wires must go to the terminals marked 'brown', black wires must go to the terminals marked 'black', and wires with the orange tracer on their edge must go to the terminals marked 'orange'. In addition to this, it is important that the wires connected to the terminals on the woofer speaker be replaced exactly as they are removed since to reverse one pair of parallel leads will cause these speakers to be out of phase with resulting poor tonal quality.
